Technical Report CHL-99-7
April 1999

Dam Safety Assurance Model Study of Tygart Dam, Tygart River, Grafton, West Virginia

Final report

Prepared for U.S. Army Engineer District, Pittsburgh
Pittsburgh, PA 15222-4186

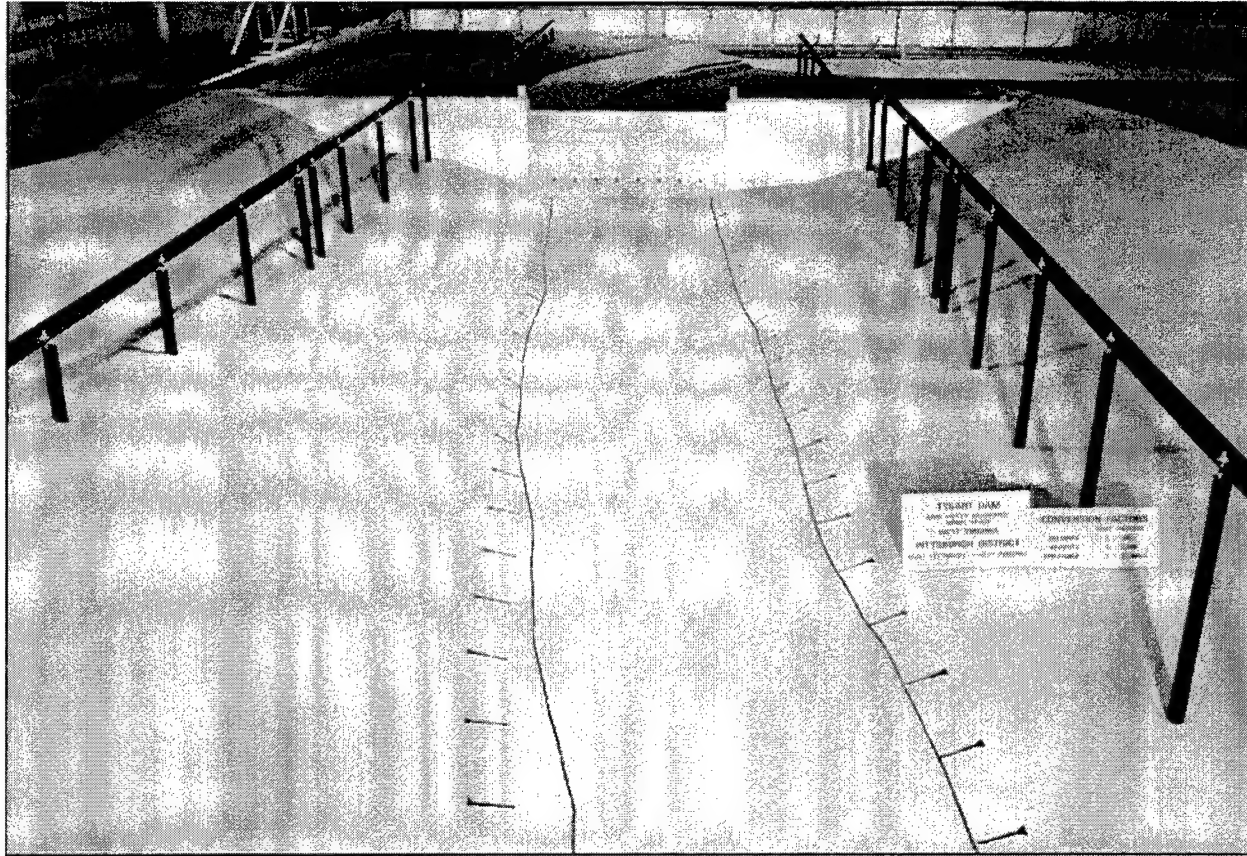
Figure 4. Type 1 existing conditions, dry bed, upstream view

The investigation was conducted using a 1:60 scale physical model (Figures 4 and 5). The basis for choosing this size model will be discussed in a following section. The model reproduced approximately a 610-m (2,000-ft) length of approach channel, the dam (Figure 4), and 610 m (2,000 ft) of exit channel (Figure 5). The model topography was modeled to existing topography supplied by the Pittsburgh District. Sheet metal templates were prepared according to location and elevation data, installed, and paved with a thin layer of cement grout (Photo 1). Sheet metal was also used to fabricate the model dam and endsill. The stilling basin was constructed of plastic-coated marine plywood. The spillway dentates were molded with plastic resin. The roadways, parapet walls, and training walls were constructed of clear plastic. All model components were constructed to close tolerances. Very smooth materials were utilized to minimize geometric distortion.

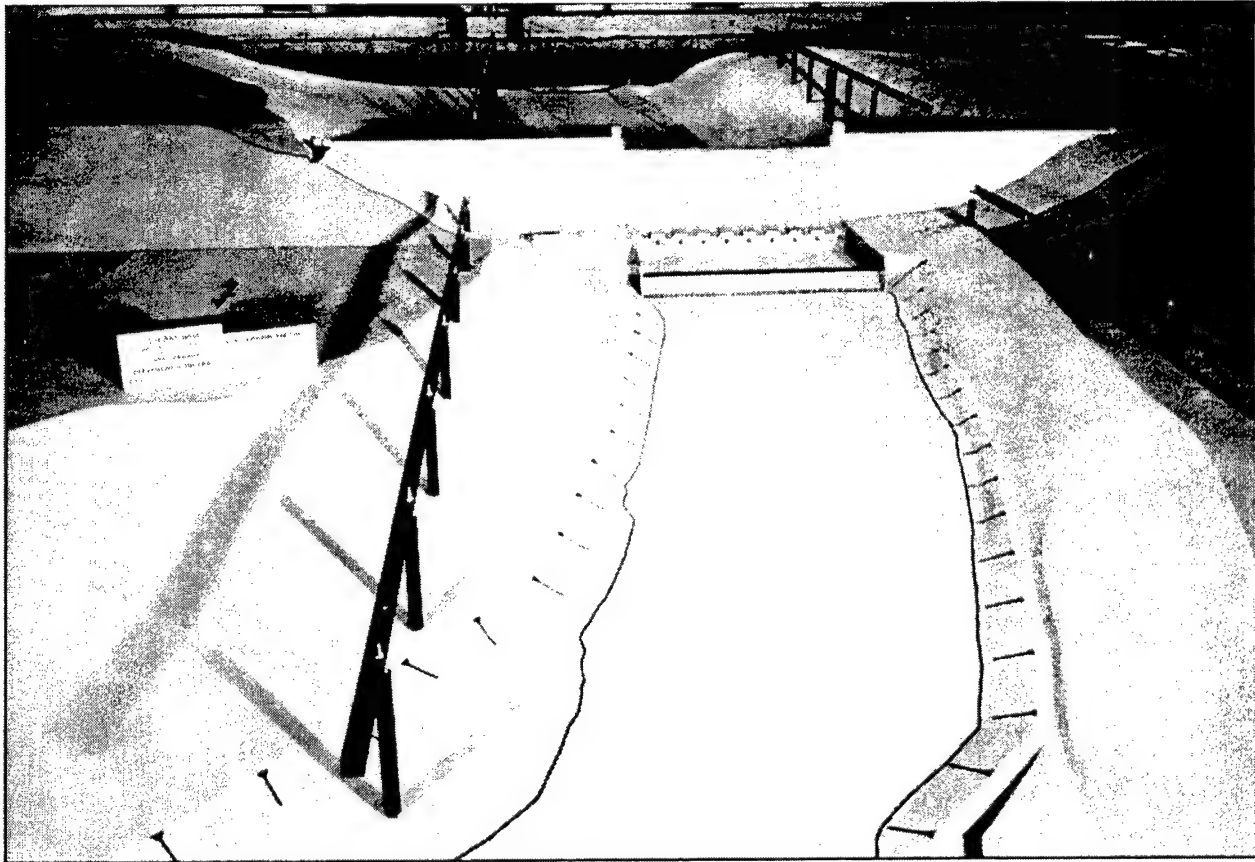
Figure 5. Type 1 existing conditions, dry bed, downstream view

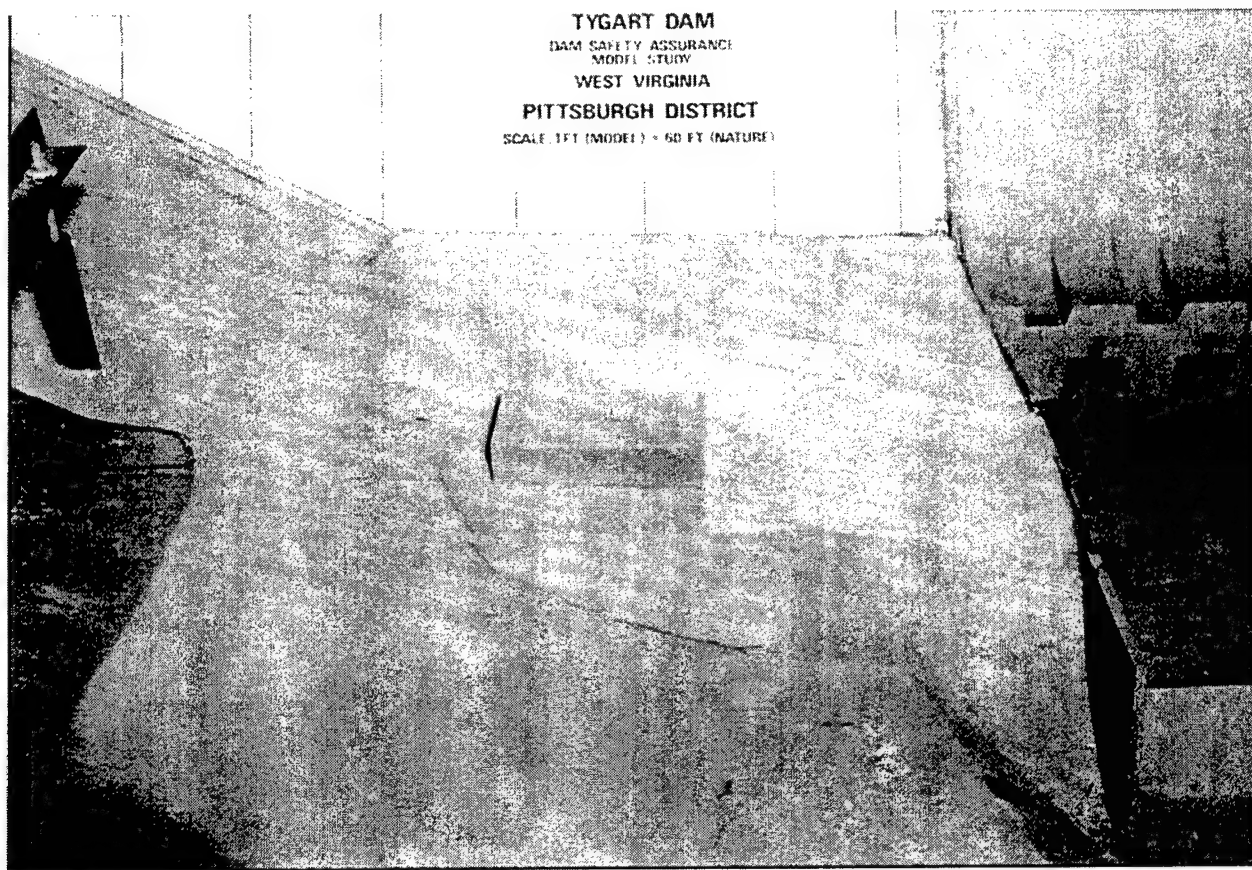
Figure 6. Type 4 design, paved apron, dry bed, right side

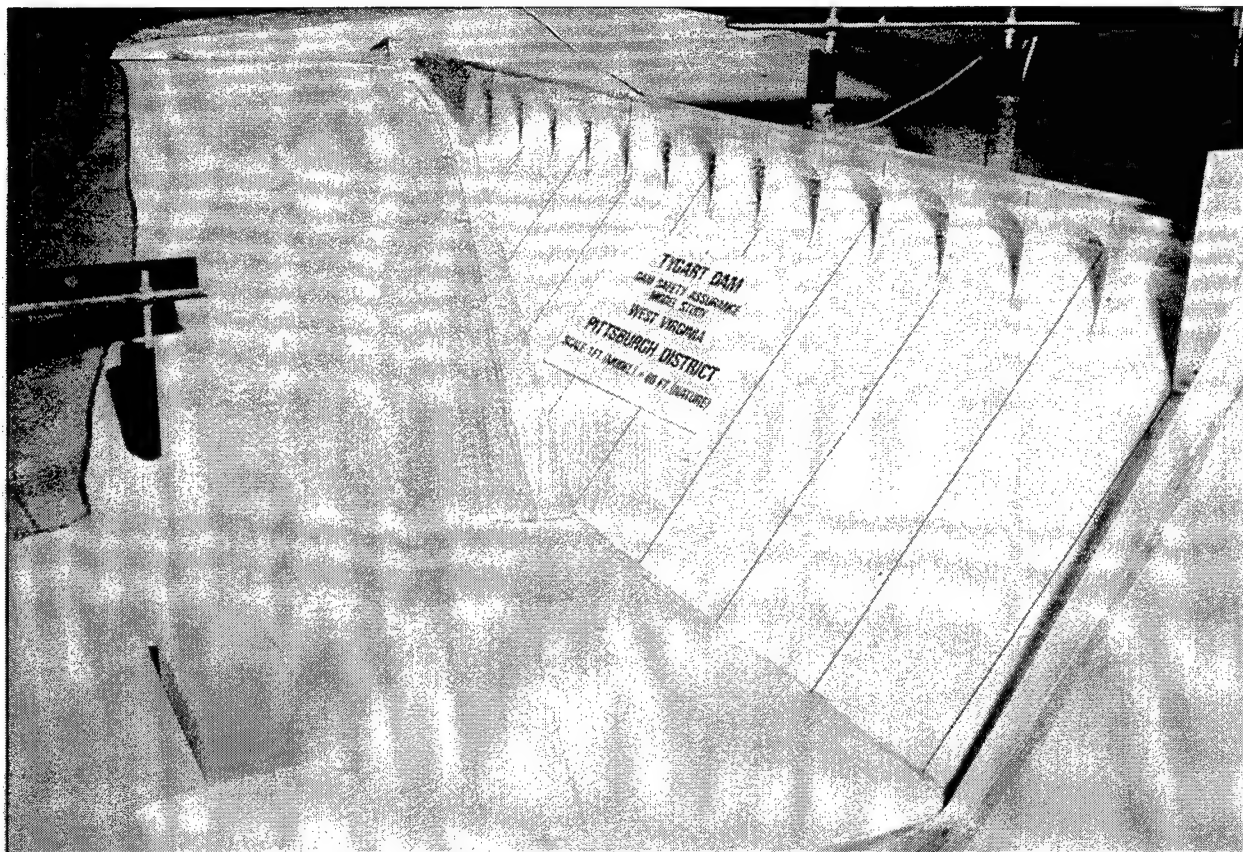
Figure 7. Type 4 design, right side gutter channel and concrete apron, dry bed

The Type 4 design also included modifications to the gutter channel, as shown in Figure 7 and Plates 12-13. At the upper end of the gutter (Plate 12), the first two arches were sealed to prevent disruption of the supercritical flow by the arch supports. The curved transition of the gutter replaces a sharp bend that caused disruption of the supercritical flow. At the lower end of the gutter (Plate 13), the flow expands onto an apron and into the stilling basin.

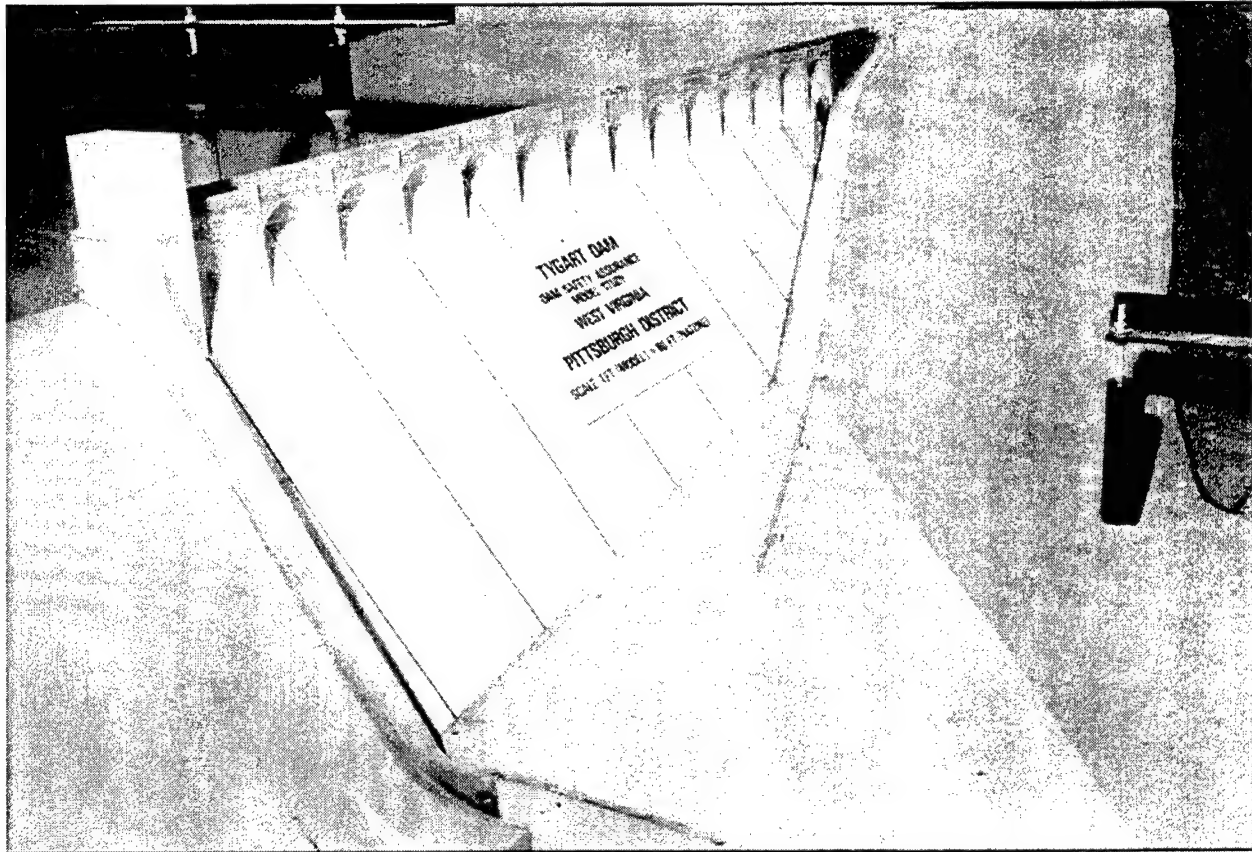
Figure 8. Type 4 design, left side gutter channel, guide wall, and paved apron, dry bed

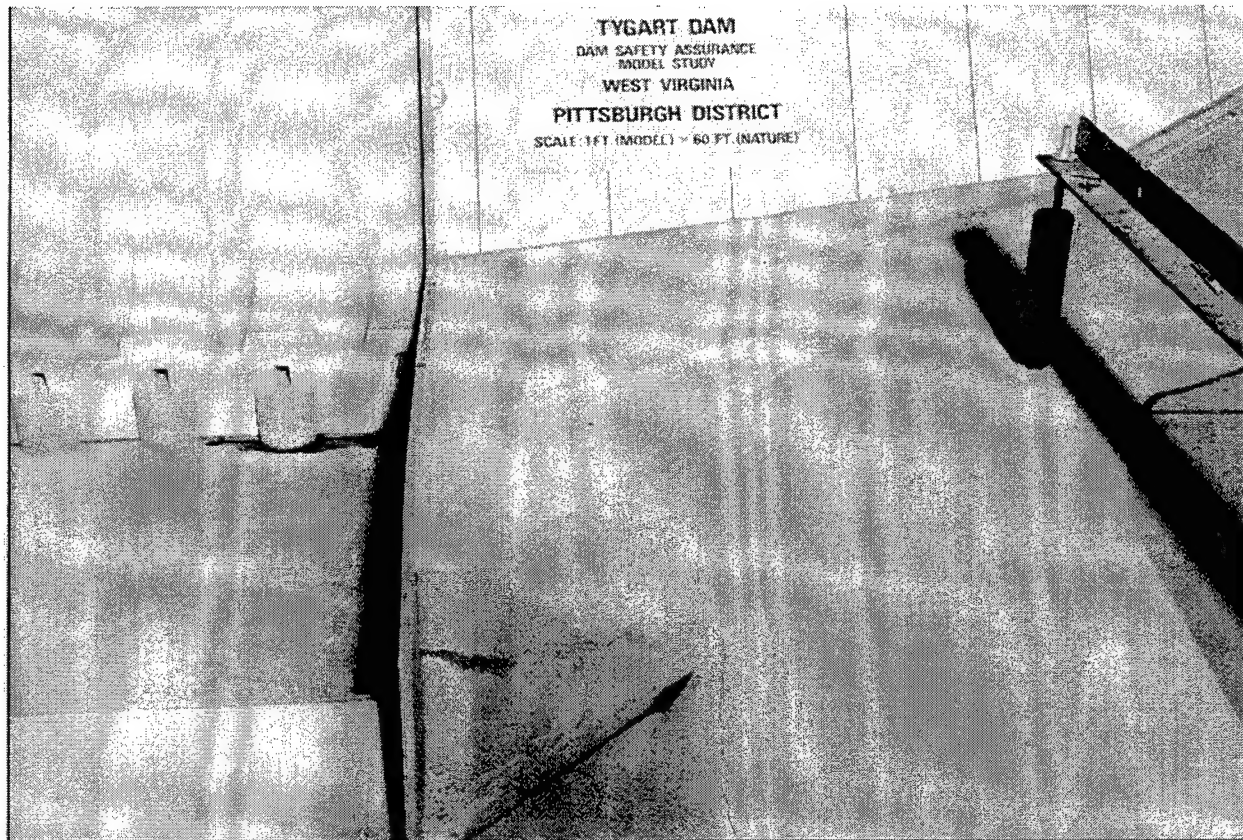
Figure 9. Type 4 design, left side guide wall and paved apron, dry bed

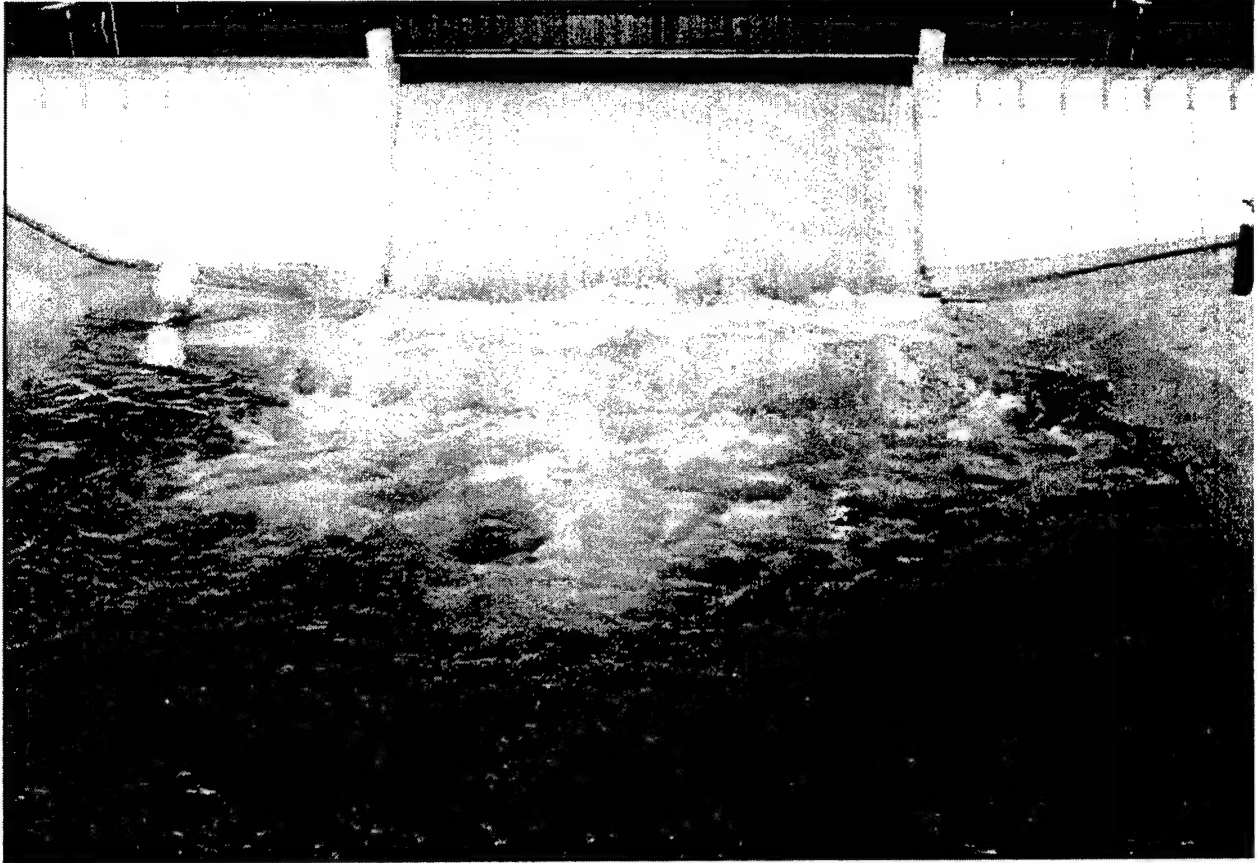
Figure 10. Type 4 design, PMF flow ($Q = 373,120$ cfs; Pool = el 1196.95; TW el = 1031.5)

With both gutter channels installed, the Tygart Dam and spillway were able to satisfactorily pass the PMF. The overall PMF conditions are shown in Figure 10. Velocities in the downstream channel were recorded to examine

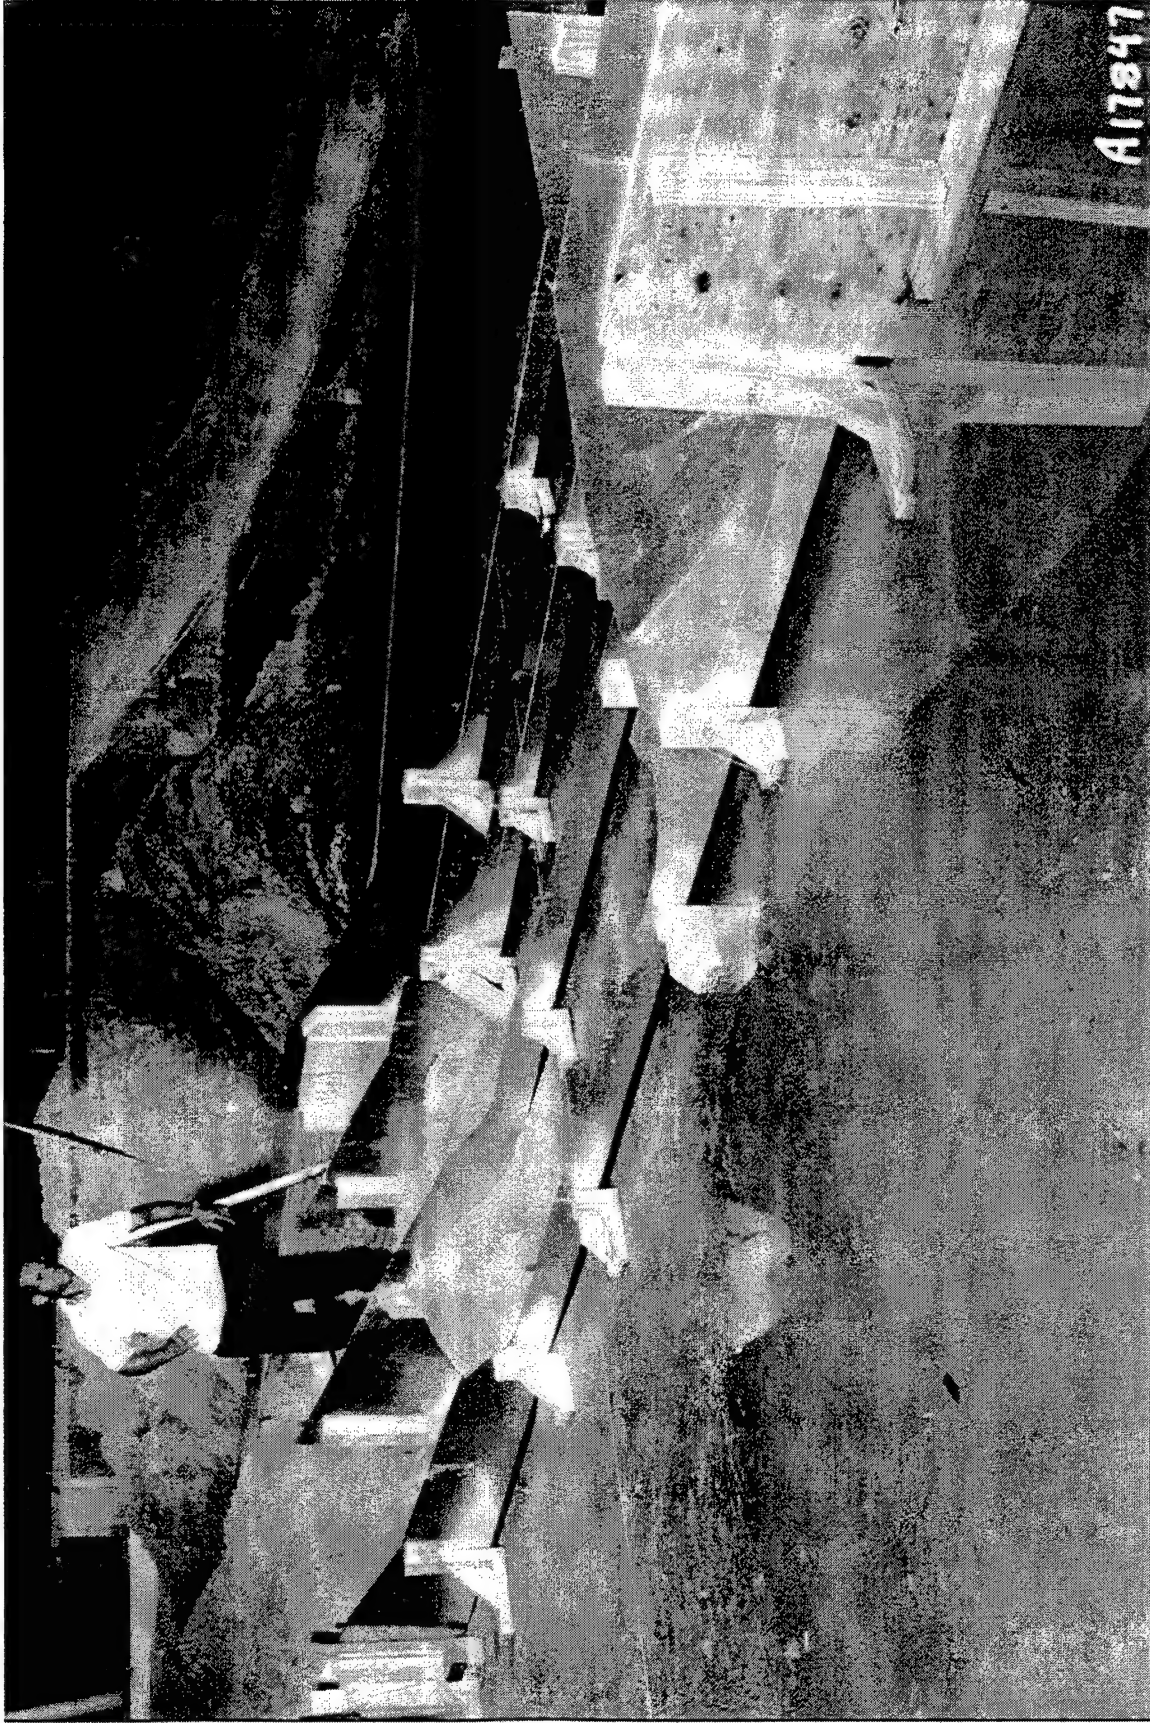
Photo 1. Tygart model construction

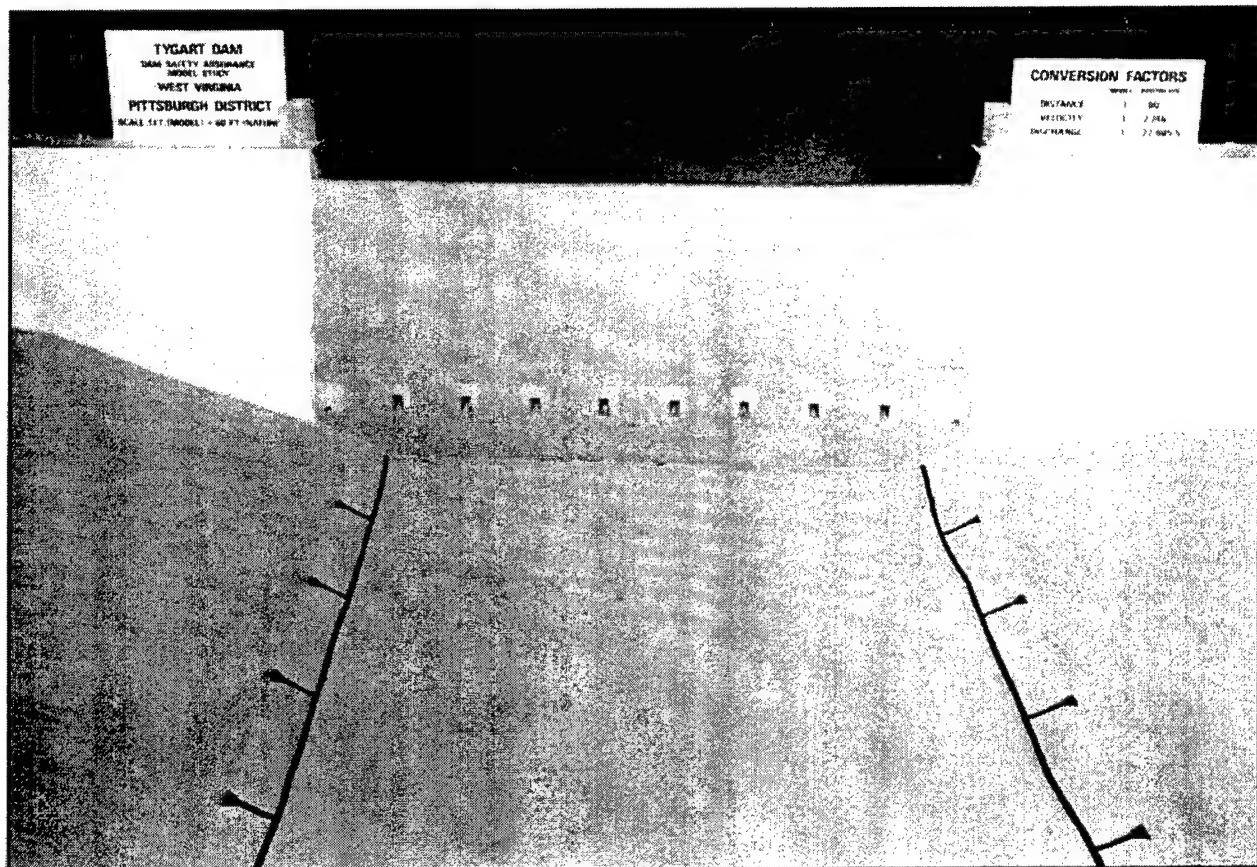
Photo 2. Tygart spillway, upstream view, dry bed

A closeup view of the upstream face of the spillway and the eight rectangular and two circular conduit openings is shown in Photo 2. At each side of the spillway are circular conduits designed for low releases. Currently, the circular conduits are not operational in the prototype. The downstream view of the model (Figure 5) shows the downstream channel alignment. In Photo 3, the details of the spillway and stilling basin such as the dentates, deflectors, and stilling weir are shown.

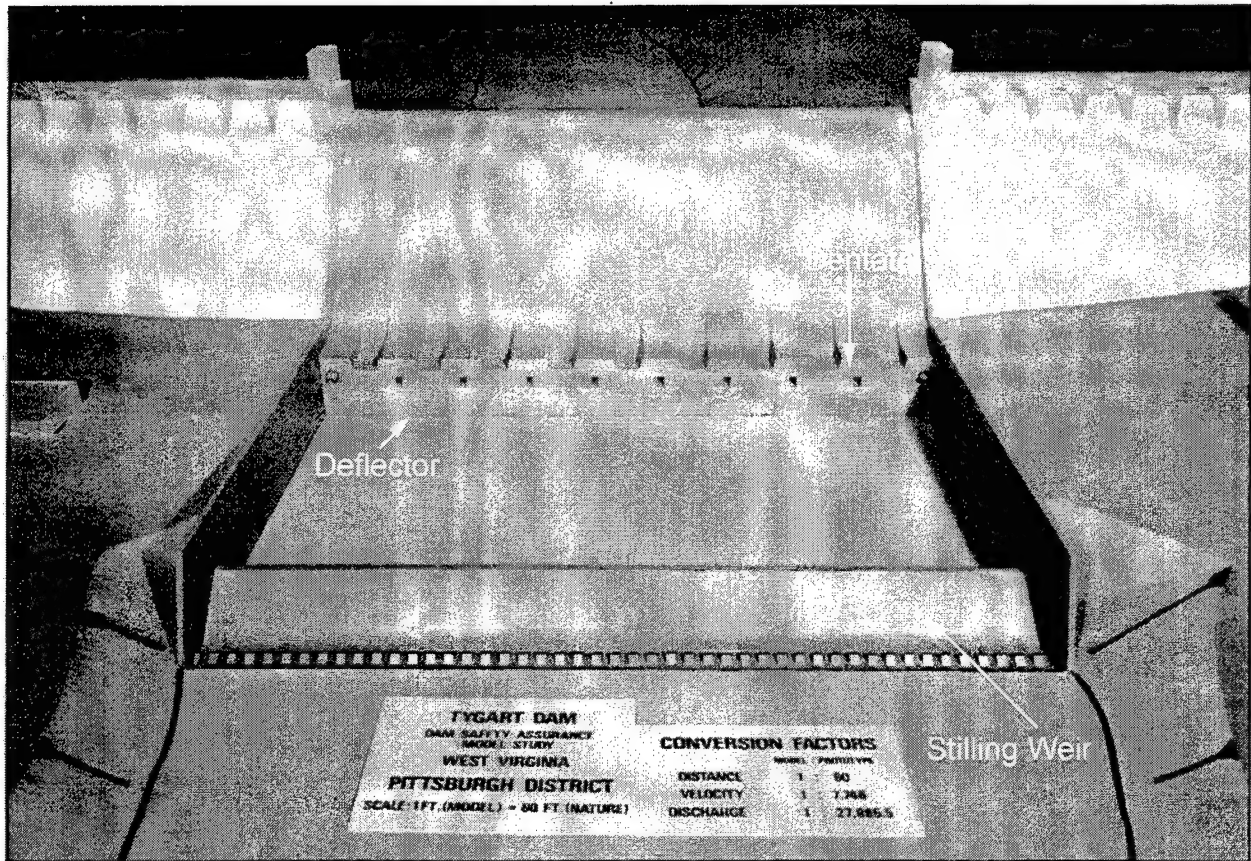
Photo 3. Tygart spillway and stilling basin, downstream view, dry bed

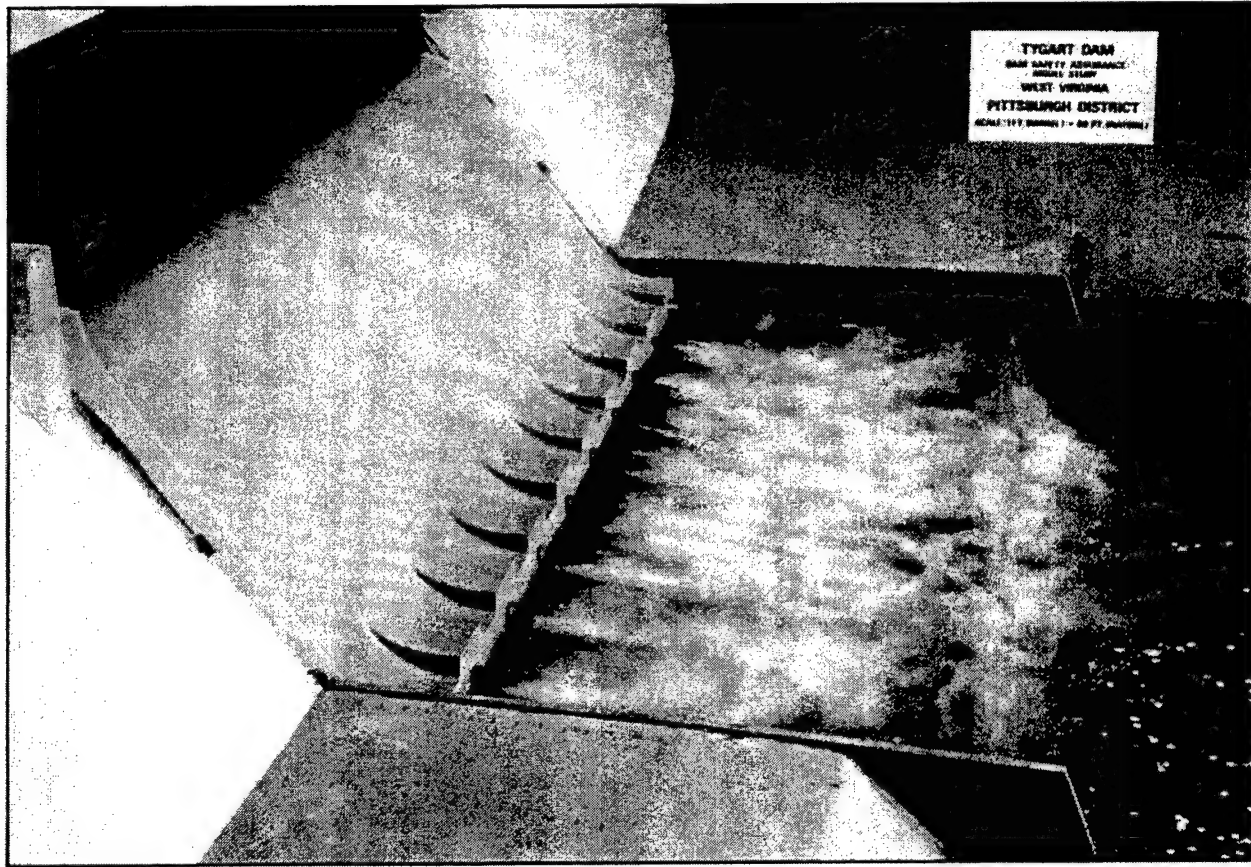
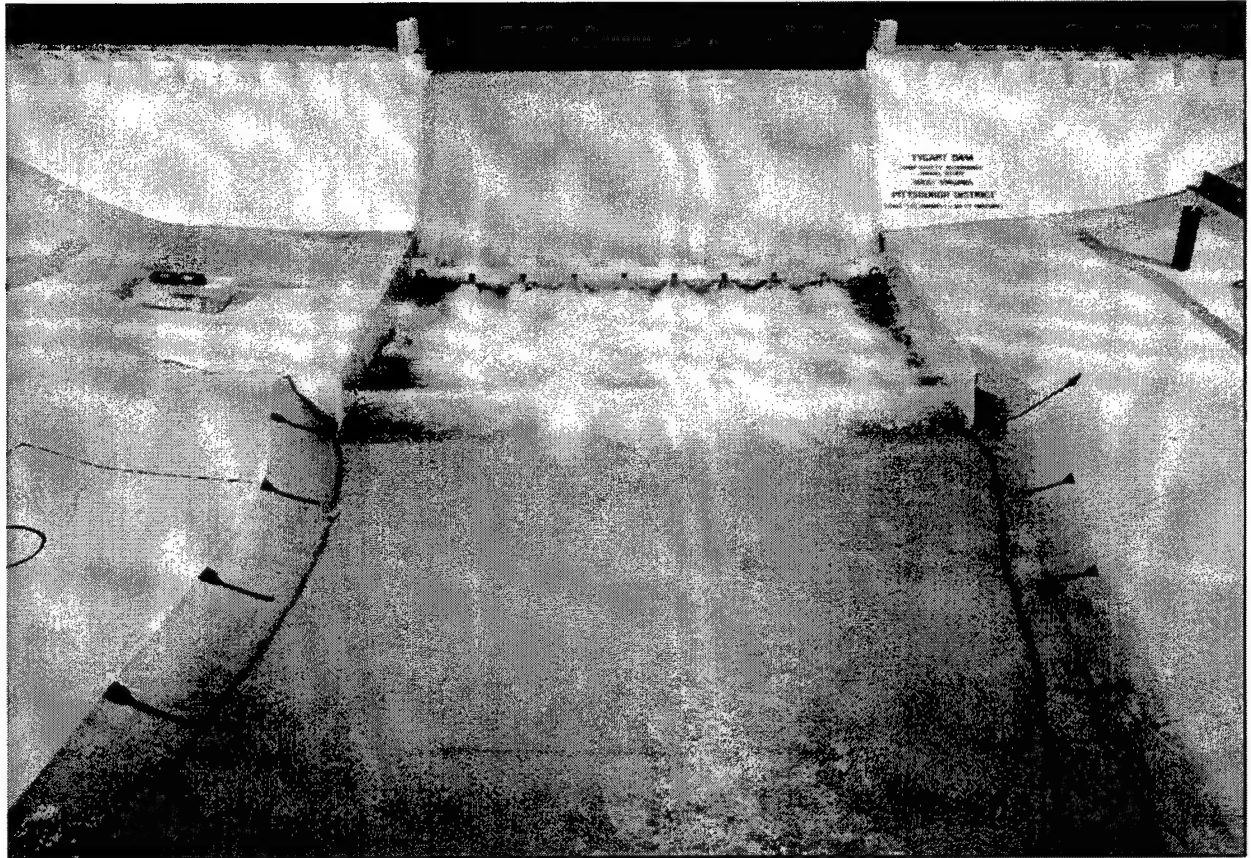
Photo 4. Tygart stilling basin flow conditions, sluice flow only ($Q = 41,580$ cfs; Pool = el 1167.0; TW el = 987.0)

Photo 5. Tygart stilling basin flow conditions, sluice flow only ($Q = 41,580$ cfs; Pool = el 1167.0; TW el = 987.0)

Condition A flow is shown in Photos 4-5 and represents flow from the rectangular conduits with the upstream pool at the crest el of 1167. These photos show the spreading of the conduit jet caused by the deflectors. The flow in the downstream channel has a tailwater el of 987, and this discharge is confined within the channel banks.

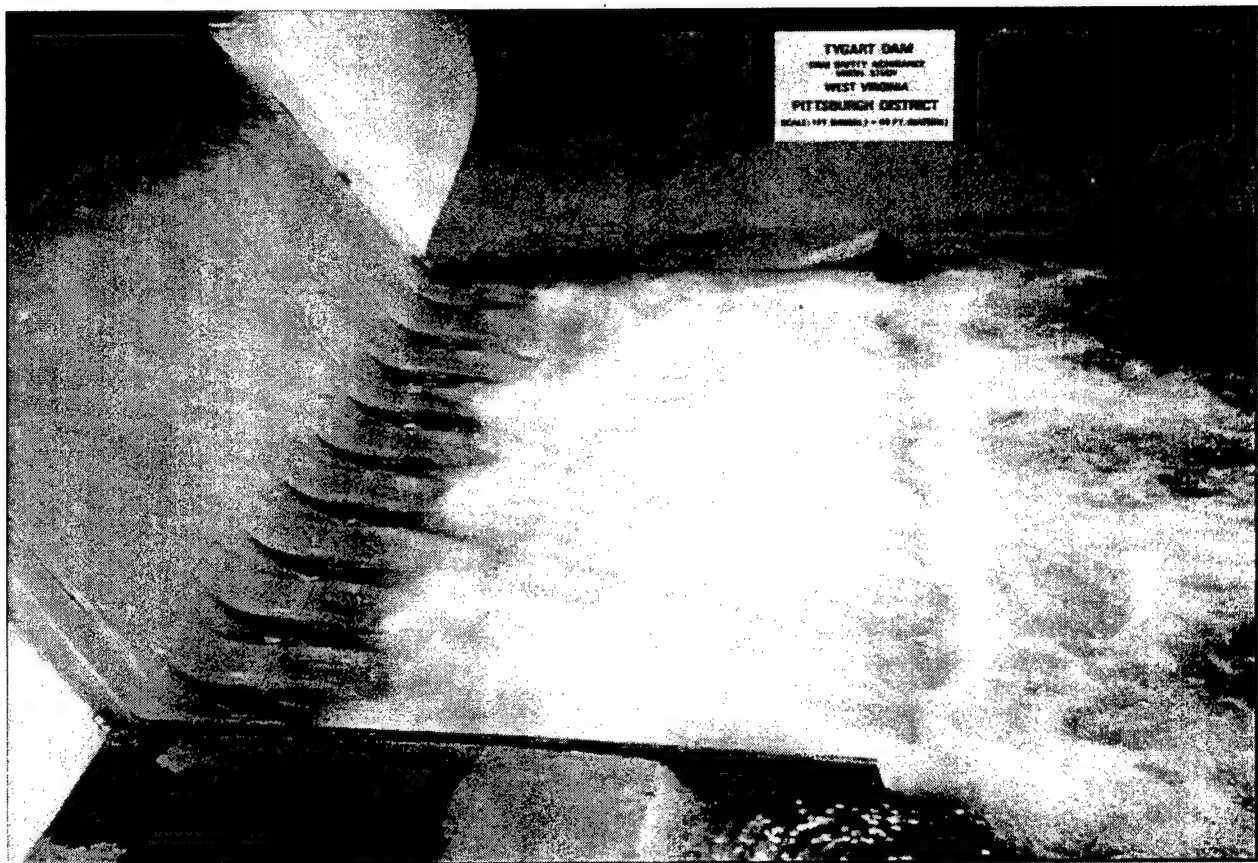
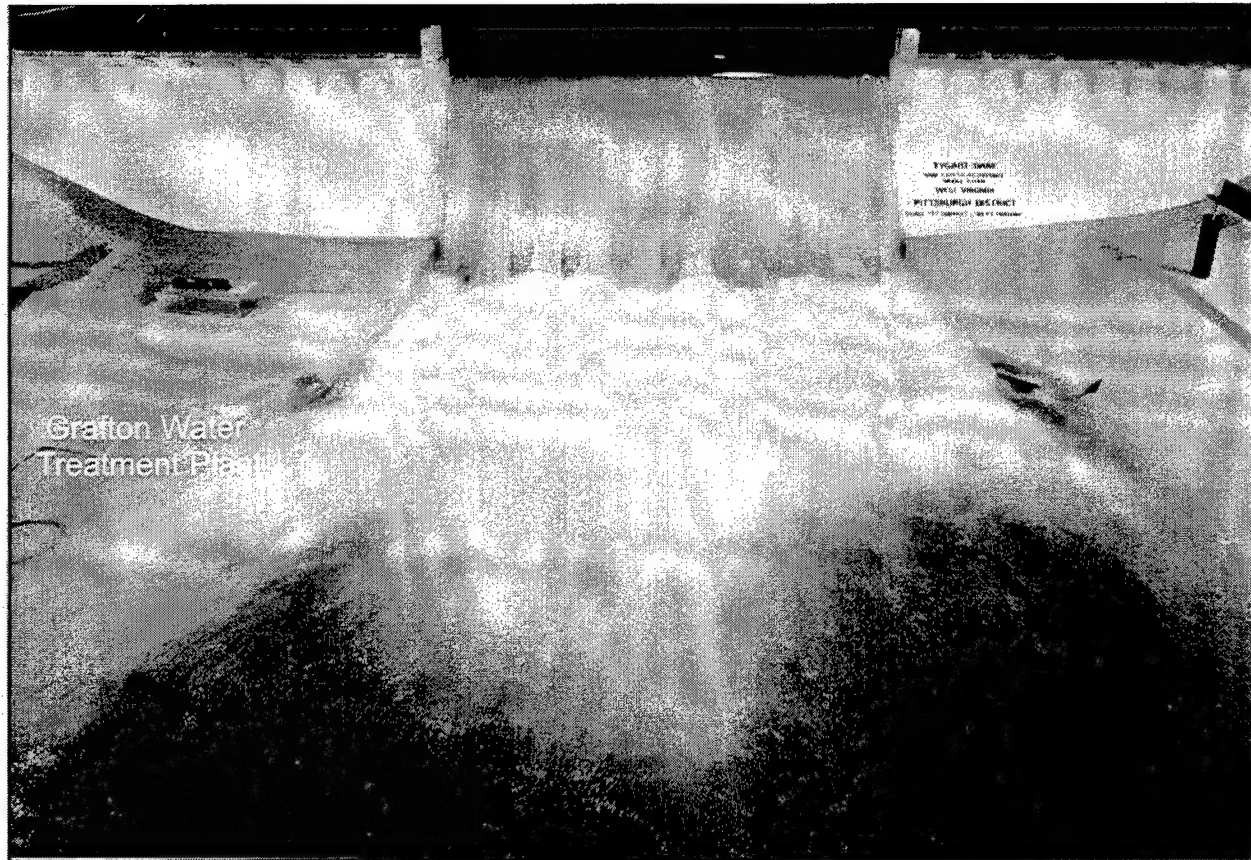
Photo 6. Tygart stilling basin flow conditions, spillway and sluice flow ($Q = 250,780$ cfs;
Pool = el 1190.0; TW el = 1020.0)

Photo 7. Tygart stilling basin flow conditions, spillway and sluice flow ($Q = 250,780$ cfs;
Pool = el 1190.0; TW el = 1020.0)

Condition B flows are shown in Photos 6-7. The discharge for the Condition B flow was determined by gradually increasing the discharge from the Condition A flow until the stilling basin walls overtopped. As the discharge was increased, the tailwater was adjusted according to Plate 5. This flow was determined to be 7,102 cu m/sec (250,780 cfs) with a corresponding pool el of 1190. The tailwater in the downstream channel with this discharge is at el 1020. Condition B causes flooding near the channel (see Grafton Water Treatment Plant, Photo 7). With flow Condition B, the weir at the end of the stilling basin causes a forced hydraulic jump in the basin. A secondary jump also occurs in the channel downstream as the flow over the weir enters the tailwater.

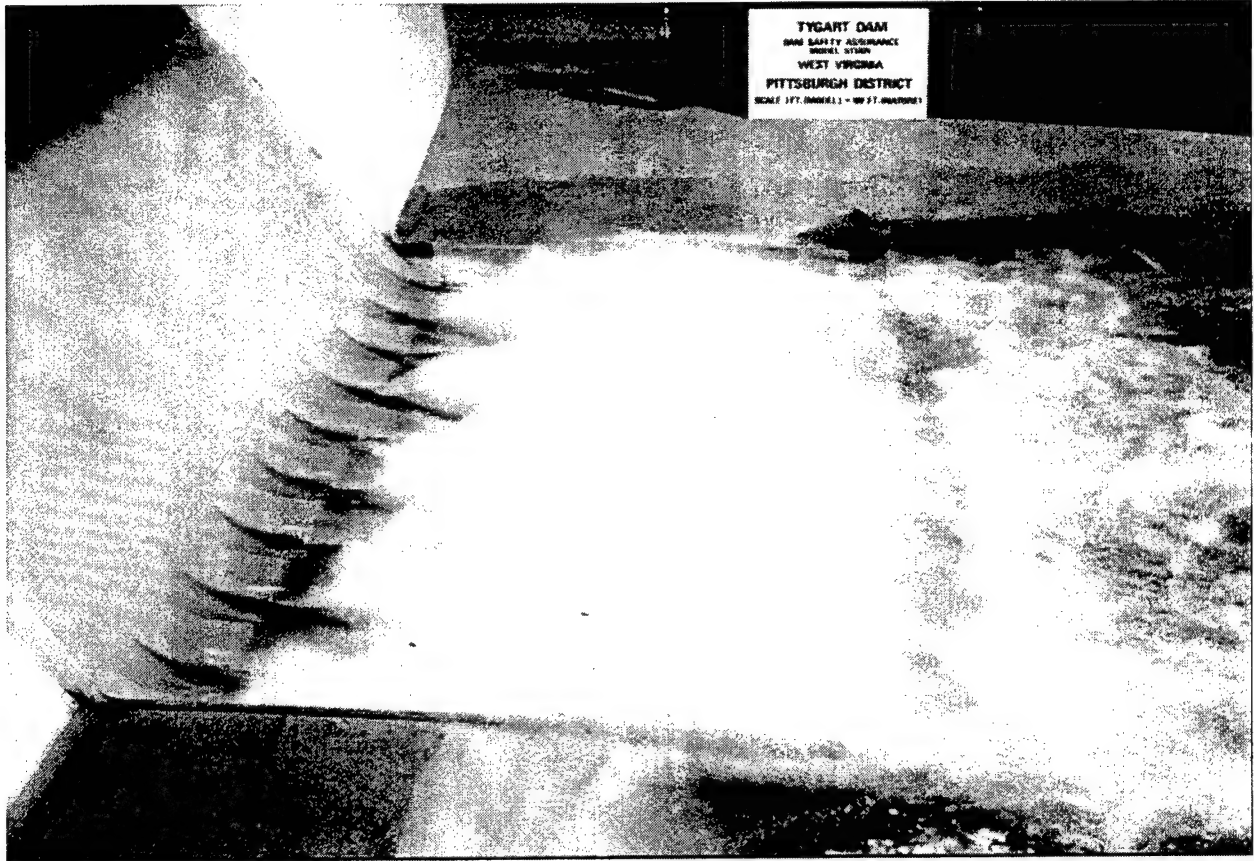
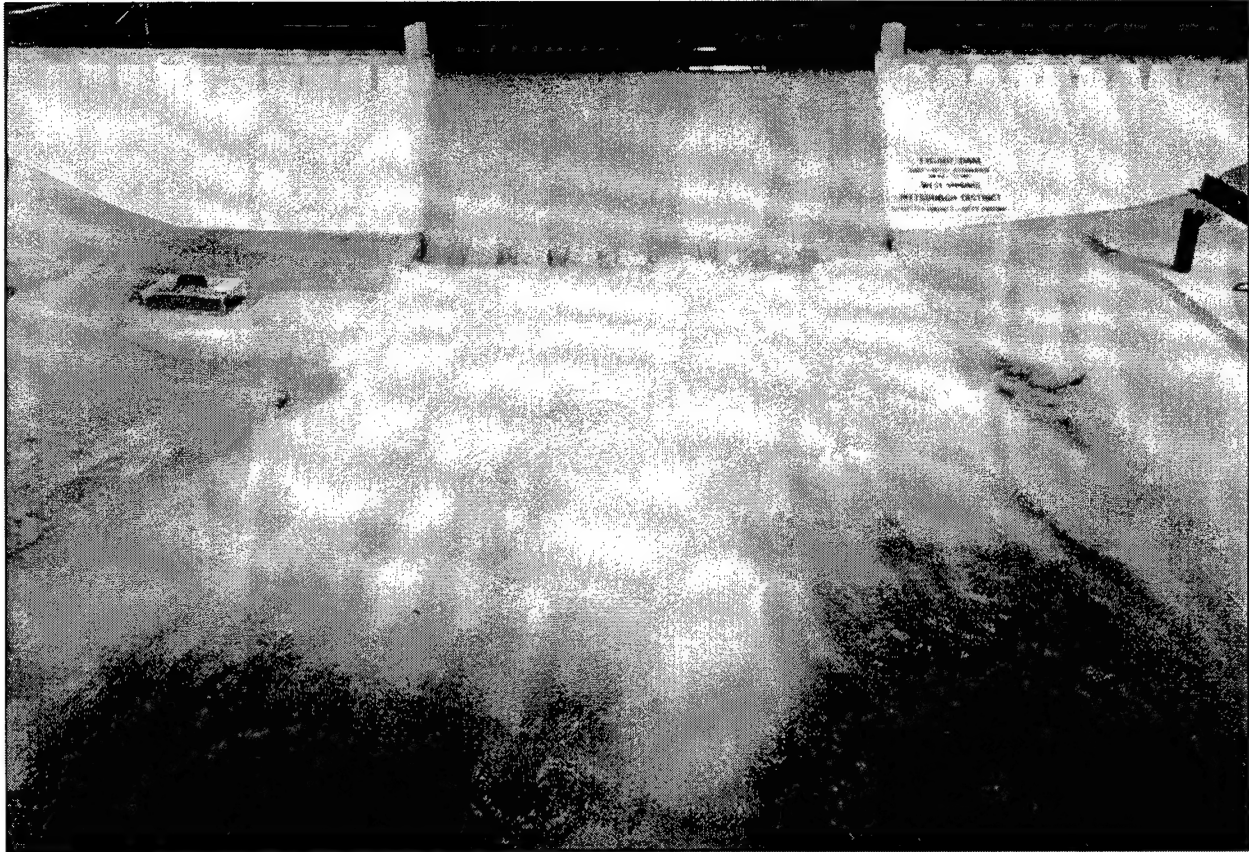
Photo 8. Tygart stilling basin flow conditions, spillway and sluice flow ($Q = 319,080$ cfs;
Pool = el 1194.25; TW el = 1026.5)

Photo 9. Tygart stilling basin flow conditions, spillway and sluice flow ($Q = 319,080$ cfs;
Pool = el 1194.25; TW el = 1026.5)

Photos 8-9 show conditions just before the pool elevation overtops the dam (Condition C). The discharge for Condition C was determined by gradually increasing the discharge until the pool elevation was the same as the top of the

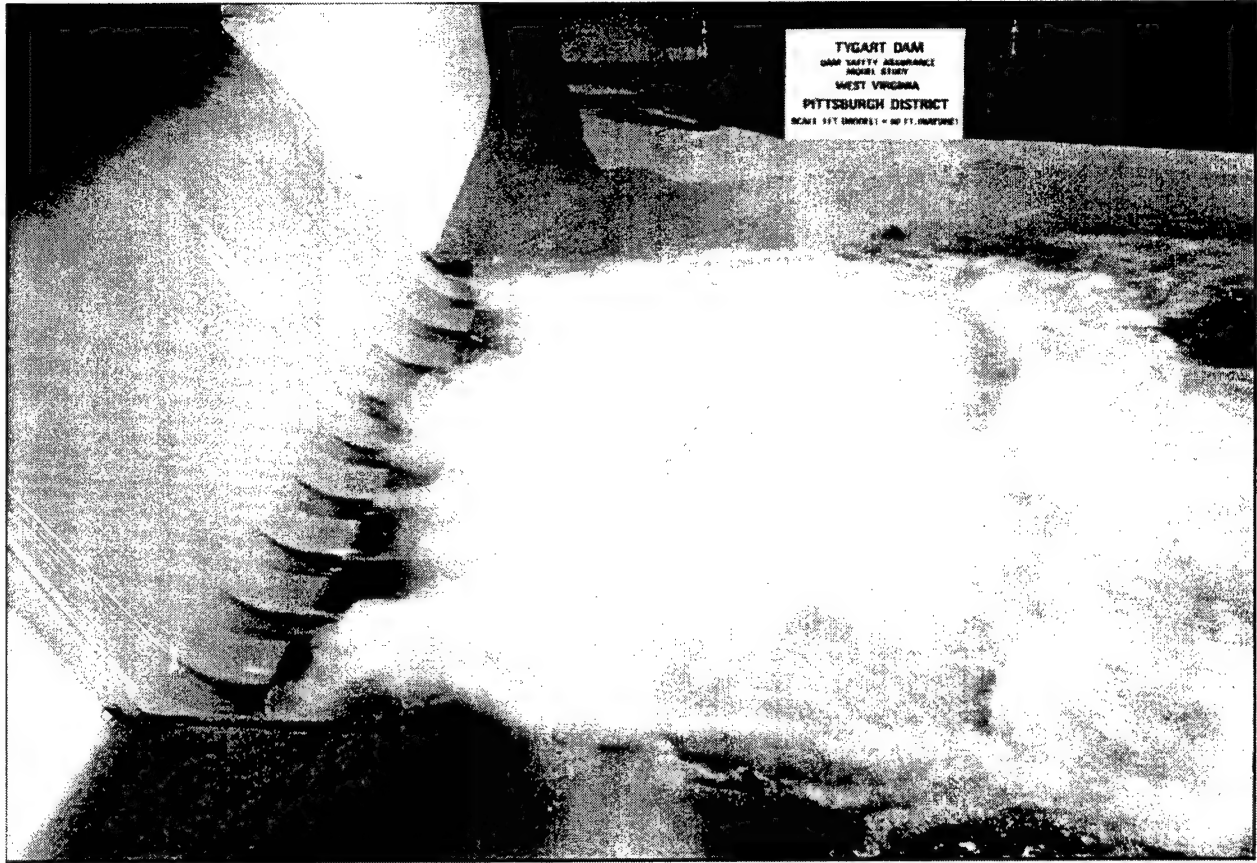
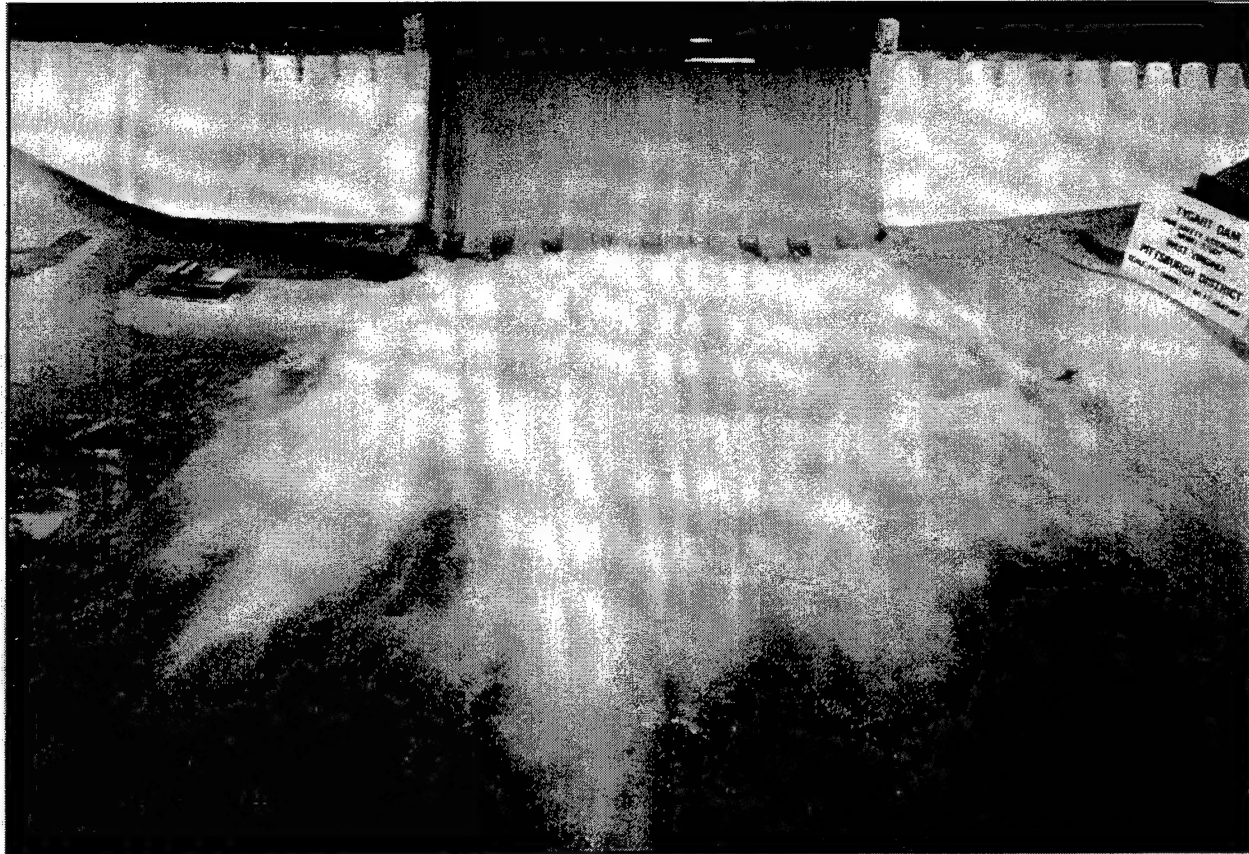
Photo 10. Tygart stilling basin flow conditions, PMF overtopping, spillway and sluice flow ($Q = 373,120$ cfs; Pool = el 1196.95; TW el = 1031.5)

Photo 11. Tygart stilling basin flow conditions, PMF overtopping, spillway and sluice flow
($Q = 373,120$ cfs; Pool = el 1196.95; TW el = 1031.5)

The PMF flow conditions, Condition D, are shown in Photos 10-11. At Condition D, the flow rate is 10,567 cu m/sec (373,120 cfs), the pool elevation is 1196.95, and the tailwater is at el 1031.5. The overtopping flow comes over the parapet walls and down the downstream face of the dam. Erosion of the natural terrain is expected to take place as the water impacts the ground surface and attempts to reenter the downstream channel. Some of the overtopping flow flanks the parapet wall on the right side and moves through the roadway opening. As shown in Photo 12, the flow is conveyed along the access roadway before spilling back down the terrain. On the left descending side of the dam, no flanking flow occurs because of higher terrain and the absence of an access roadway. The downstream flow conditions show that a forced hydraulic jump is still occurring in the stilling basin, the secondary jump has moved even farther downstream, and significant surface turbulence and wave action are associated with the secondary jump.

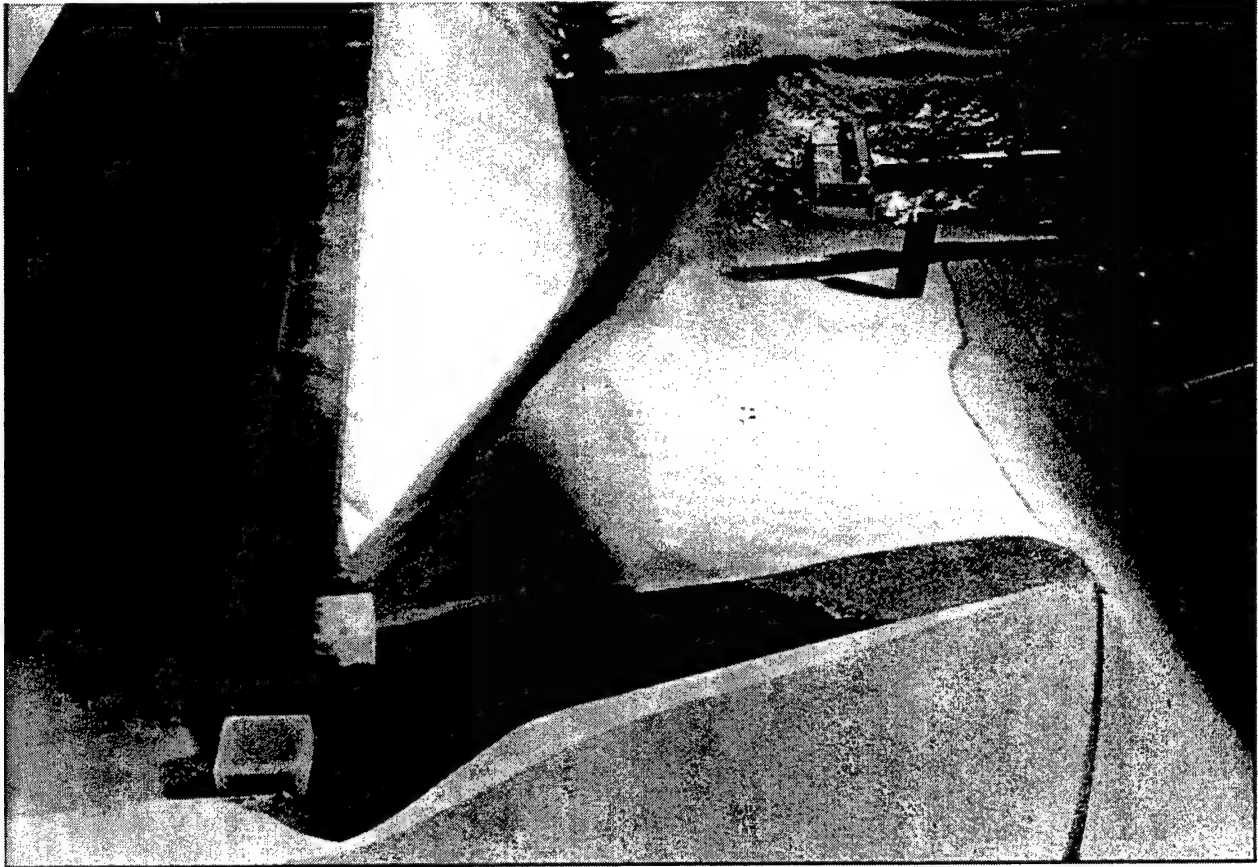
Photo 12. Tygart overflow on right side of dam, PMF flow($Q = 373,120$ cfs; Pool = el 1196.5; TW el = 1031.5)
